# *Tom Camp Inspection Services, LLC*

## Property Inspection Report

Main St, Colorado Springs CO, 80914  
Inspection prepared for: John Smith  
Agent: Support - Home Inspector Pro

Inspection Date: 10/16/2009 Time: 10:00 am  
Age: 25 years Size: 2700 + SF  
Weather: clear

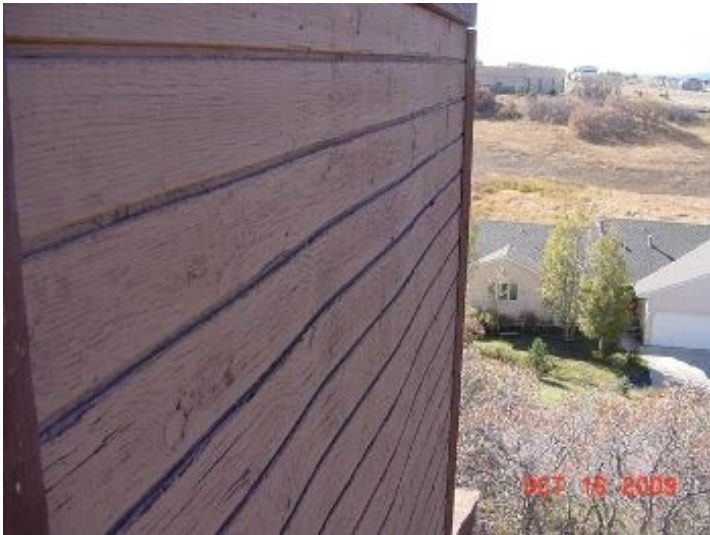
Materials: Wood Siding  
Observations: weathered in some areas on west side of house.

wood siding on west side by chimney weathered

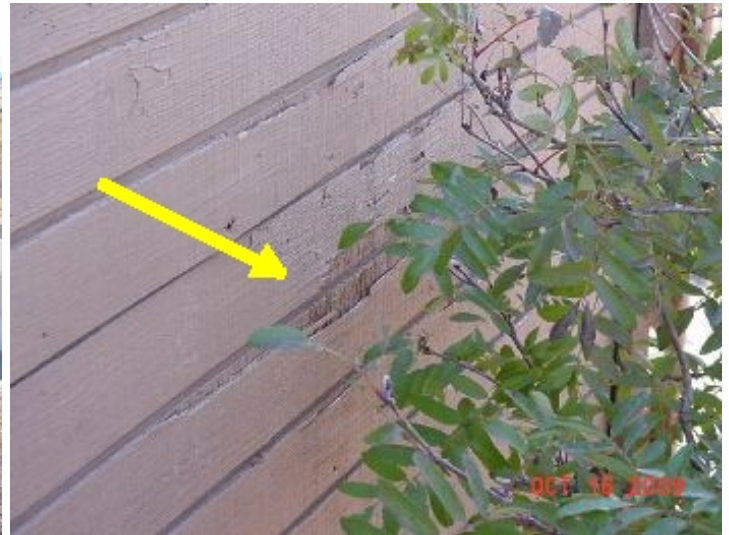
weathered wood siding

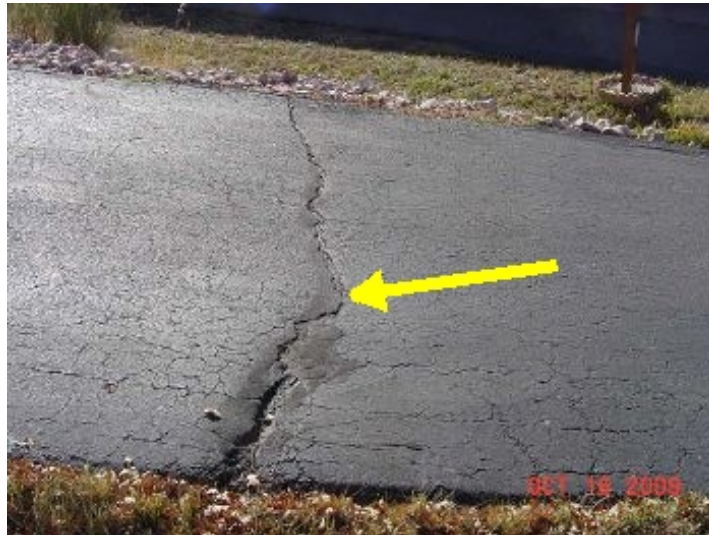
Materials: Asphalt  
Observations: Typical cracking was observed at the Asphalt surfaces. Cracks had been sealed. Recommend monitoring cracks and resealing when necessary.

monitor cracks in drive for future repairs

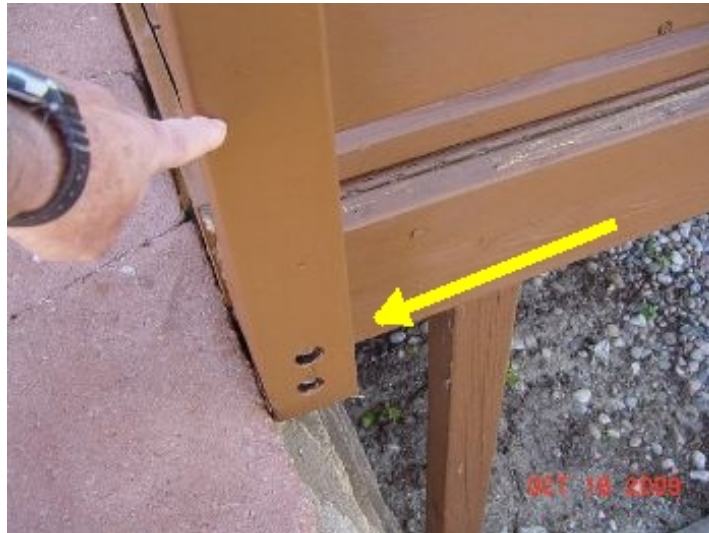
Materials: Wood  
Observations: Unstable railing at end on west side of house

Loose Railing, needs re-tightened

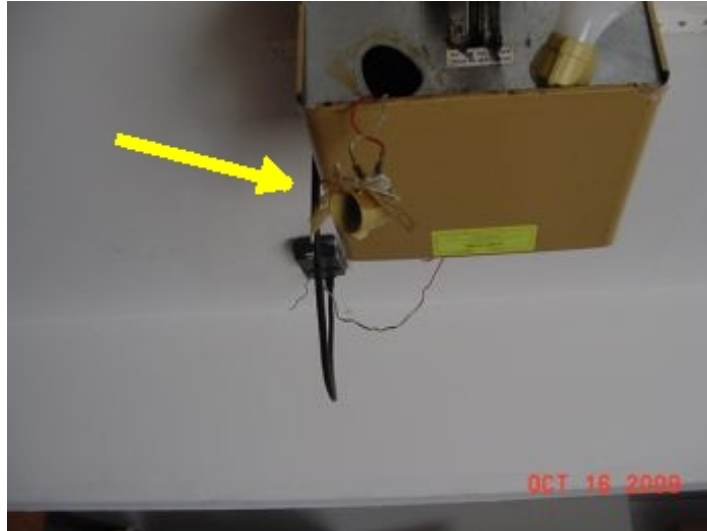
Garage		
Page 6 Item: 4	Automatic Opener	• The Chamberlin opener light socket is out of place and poses a safety hazard and could cause electrical shock.
Electrical		
Page 8 Item: 12	GFCI and AFCI	• There is no GFCI protection at Kitchen.
Page 8 Item: 13	Smoke Detectors	• The smoke alarm(s) located at the lower level did not operate when tested. You need to be alarmed in case of a fire. Recommend repair or replacement of the smoke alarm. Check the batteries every month for proper operation.

Observations: The Chamberlin opener light socket is out of place and poses a safety hazard and could cause electrical shock.

Light socket is out of place and could cause electrical shock

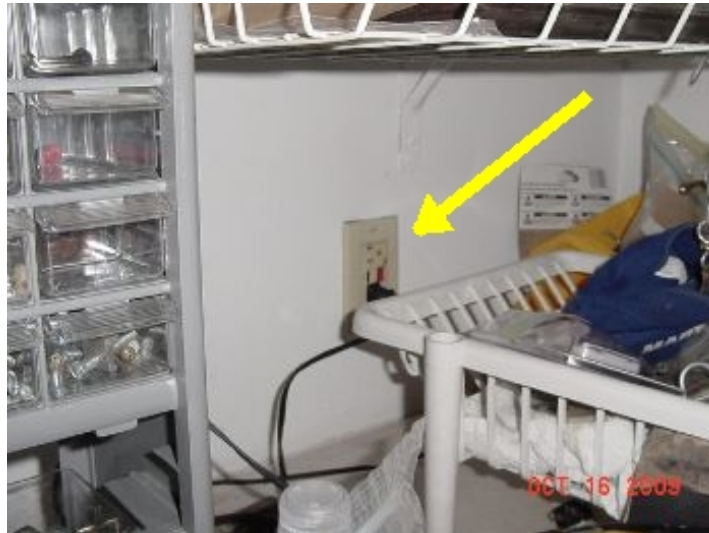
Garage • Bathroom(s) • No AFCI's Present. Not Required  
 Observations: Bathrooms are protected by GFCI located in garage above work bench • **There is no GFCI protection at Kitchen.**

GFCI located in garage which feeds bathroom outlets

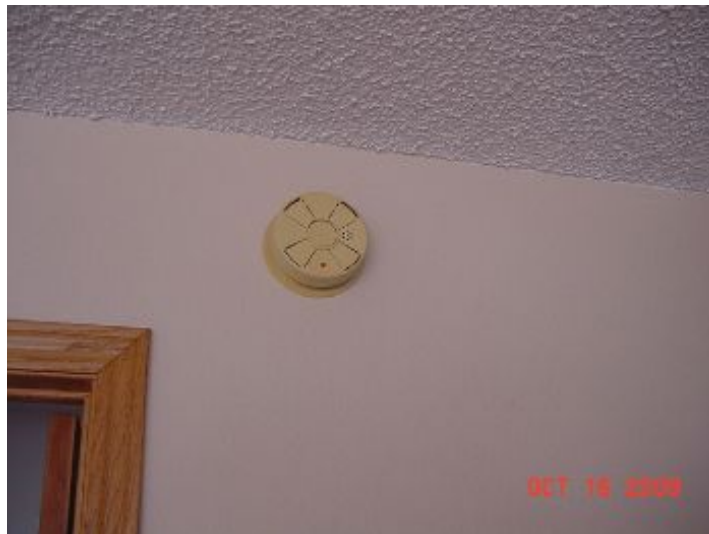
Operated when tested at upper level  
 Observations: **The smoke alarm(s) located at the lower level did not operate when tested. You need to be alarmed in case of a fire. Recommend repair or replacement of the smoke alarm. Check the batteries every month for proper operation.**

smoke detector at lower level did not work when tested

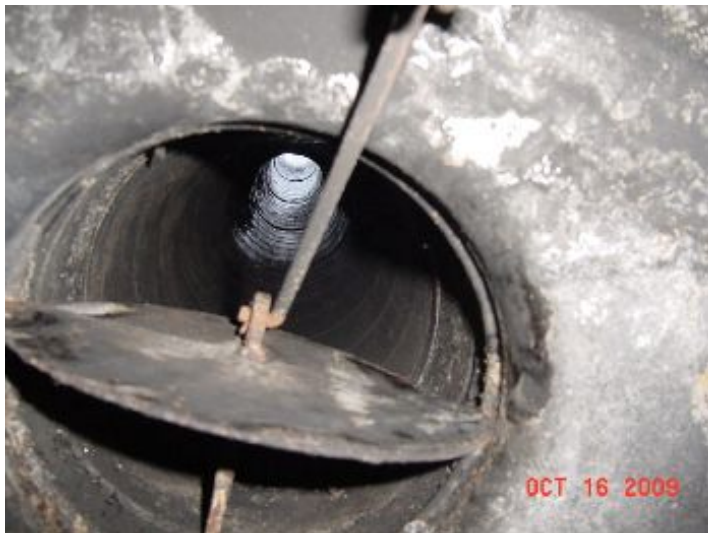
Observations: Recommend cleaning flue pipe prior to use

Fire Place Damper & Flue Pipe

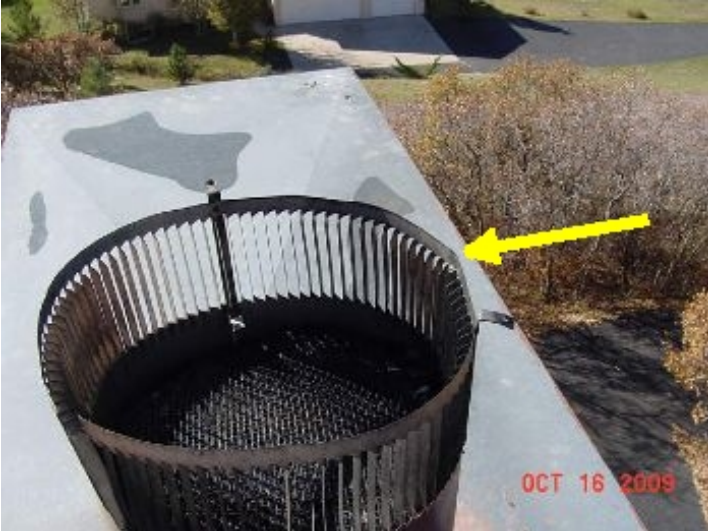
Materials: Framed  
Observations: Vent Cap missing at fireplace, wood siding has weathered on west and east sides of fireplace chimney.

Cap missing

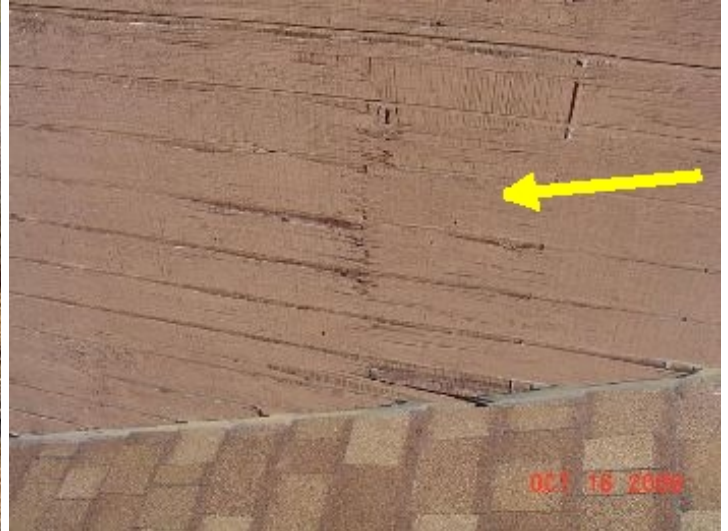
weathered wood siding

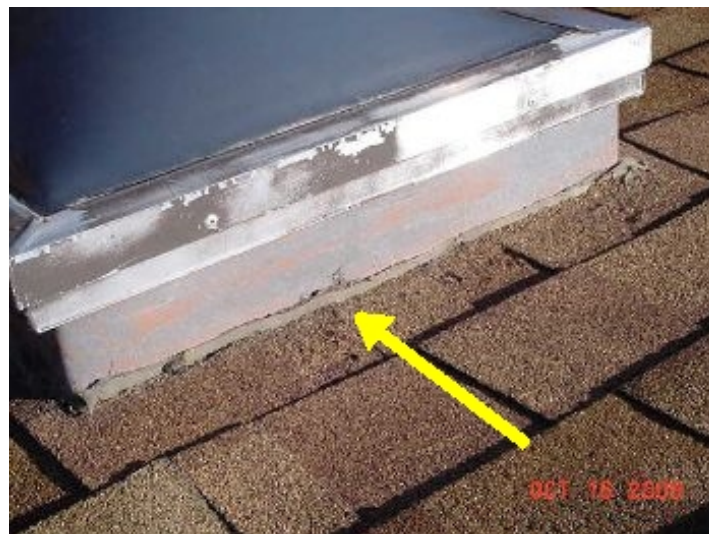
Materials: Curb Type  
Observations: Recommend caulking around skylight, even though no leaks were observed.

Skylight should be re-caulked
